# Voluntary Implementation of Forestry Best Management Practices in East Texas

Results from Round 8 of  
BMP Implementation Monitoring

December 2011

Sustainable Forestry  
Water Resources Program

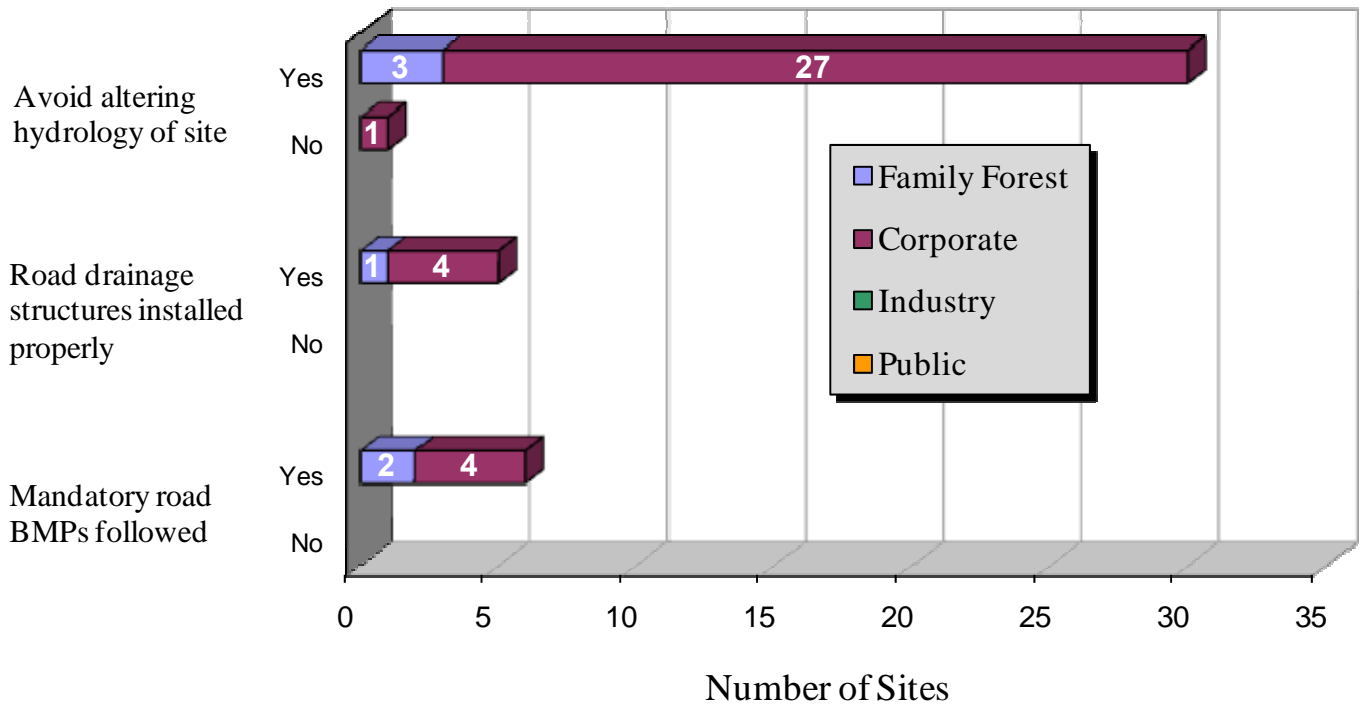
Figure 9. BMP Implementation on Wetlands by Ownership Type.

Thirty-one sites had wetland or “wetland like” areas – not necessarily jurisdictional wetlands. These sites had an overall implementation of 98%. No significant risks were noted and all mandatory road BMPs for wetlands were followed. See Table 8 and Figure 9.

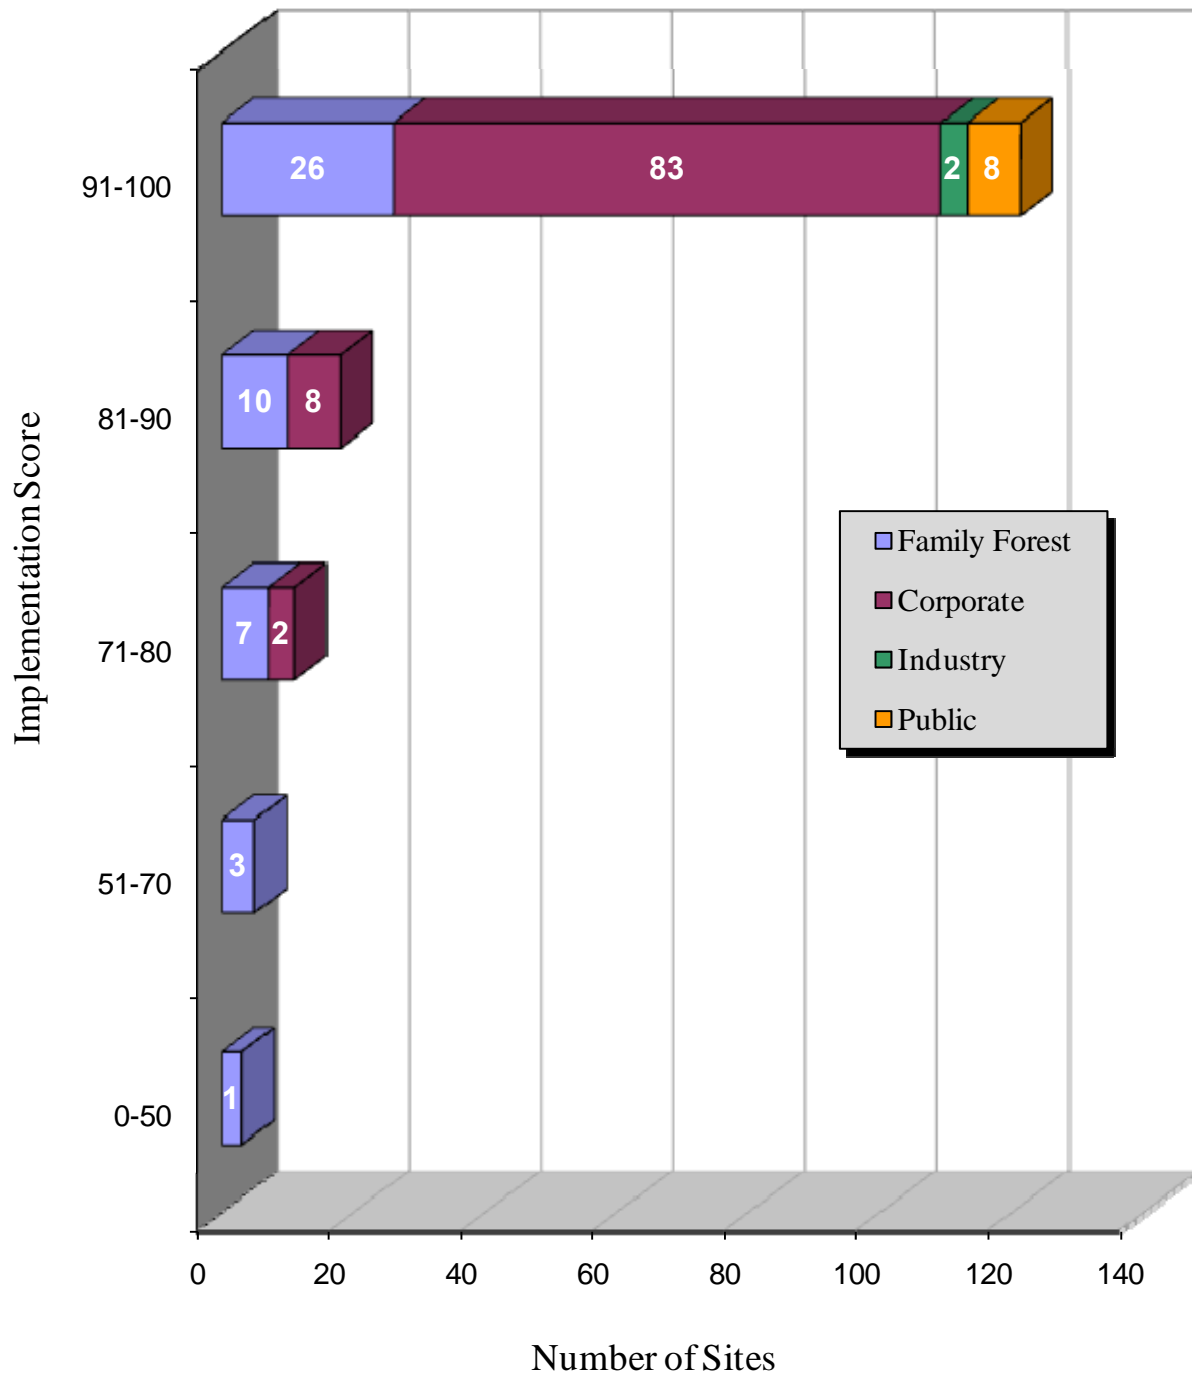
Figure 11. Overall Implementation Scores by Number of Sites and Ownership.

To illustrate the range of the overall implementation scores, Figures 10 and 11 separate the results into five categories: 0-50%, 51-70%, 71-80%, 81-90%, and 91-100%. Figure 10 spatially illustrates implementation across all ownership types. Figure 11 demonstrates the distribution of sites by implementation score class and ownership type.

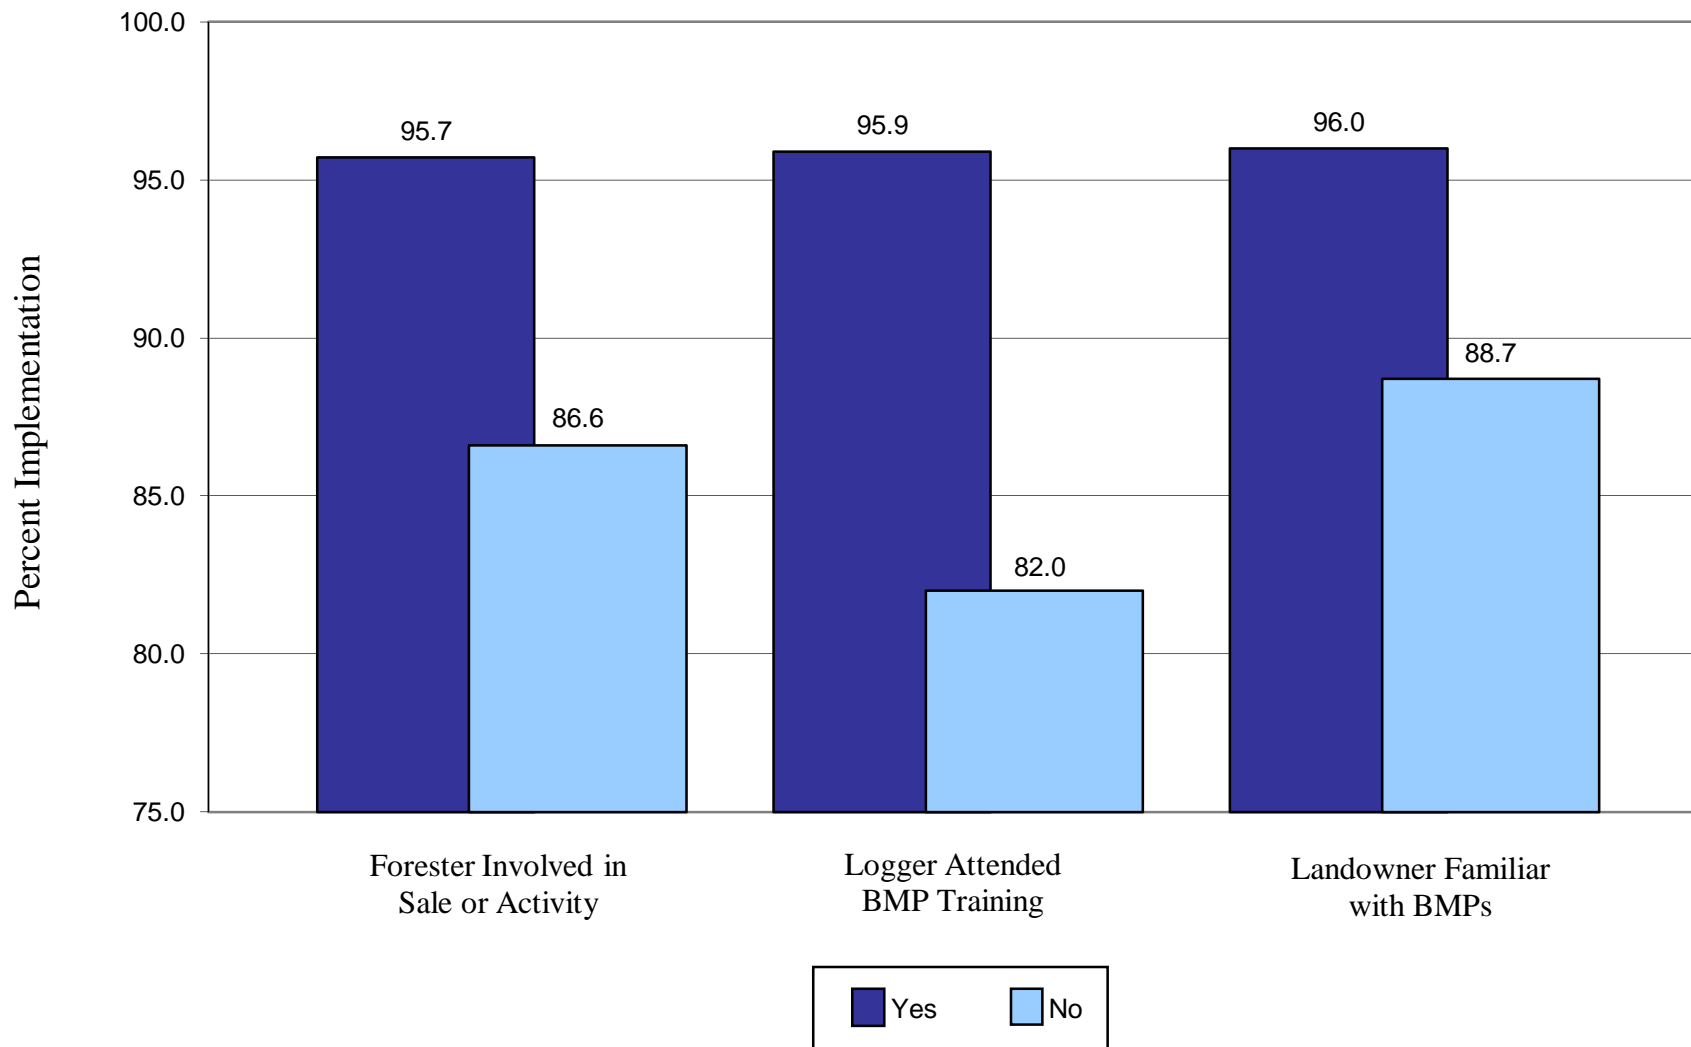
Figure 14. Overall Implementation by Various Types of Involvement.

BMP implementation was higher when a professional forester was involved in the sale or activity. One hundred thirty-five sites were identified as having a professional forester involved and had an implementation rating of 95.7%. Sites in which there was no forester involvement had a BMP implementation rating of 86.6%. See Figure 14.

Texas Forest Service conducts BMP training workshops for logging contractors. One hundred thirty-eight inspections identified the logging contractor as having attended the formal BMP training, with an implementation of 95.9%. Sites in which the activities were administered by a logger that did not attend the formal BMP training or where the logger was unknown had an implementation rating of 82.0%. See Figure 14.

Sites whose owners were not familiar with BMPs (24) had an overall implementation rating of 88.7%, while sites whose owners were familiar with BMPs (126) had an implementation rating of 96.0%. See Figure 14.

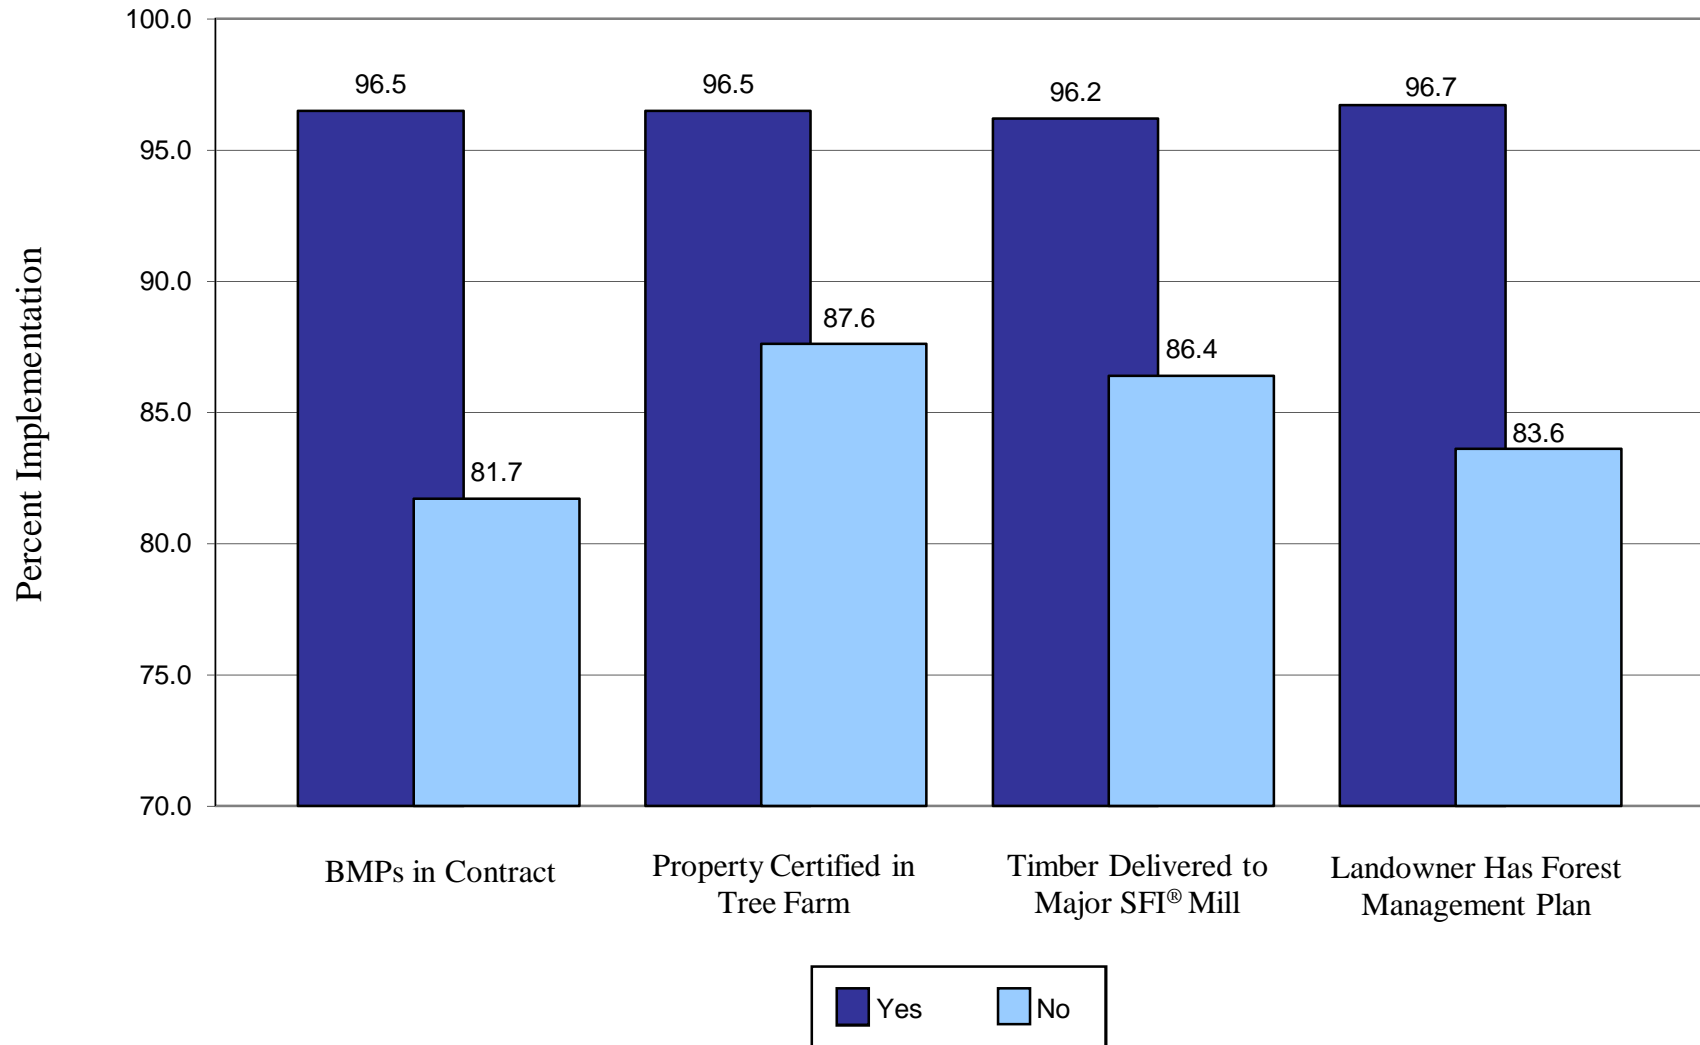
Figure 15. Overall Implementation by Various Categories.

BMPs were included in the timber sale contract on 133 sites. Implementation on sites with BMPs in the contract was 96.5%, while implementation on sites without BMPs in the contract, or where BMP inclusion was unknown, was 81.7%. See Figure 15.

Members of the American Tree Farm System<sup>®</sup> are required to implement BMPs in order to maintain their certification. Sixteen sites were identified as being Tree Farm certified and had an implementation rating of 96.5%, while implementation for eligible nonmembers on 37 sites was 87.6%. See Figure 15.

BMP implementation was higher on sites in which the receiving mill was known to be a SFI<sup>®</sup> member. This applied to 128 sites with an implementation rating of 96.2%, compared to an 86.4% rating on the 22 sites in which the timber went to other mills or the receiving mill was unknown. See Figure 15.

Landowners who have a forest management plan are more likely to use BMPs. On the 128 sites in which landowners had a forest management plan, implementation was 96.7%, compared to an implementation rating of 83.6% on the 22 sites that did not have a forest management plan or where it was unknown if a plan existed. See Figure 15.
